Manhole Inspection Summary

Manhole # S35K__004MH

Insp Date: **9/23/08 11:51 AM**

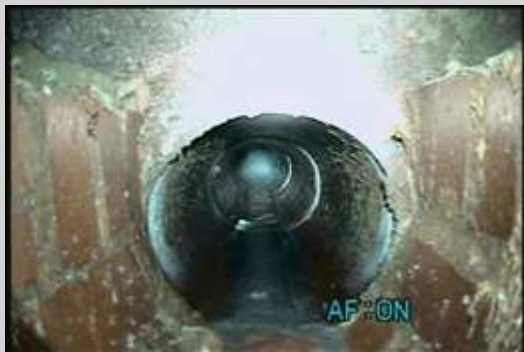
12 O'Clock Outflow

8 in. Circular Gravity Sewer
Pipe Out @ 12 O'Clock

Pipe Material: **Clay** ☐ Pipe Lined

Invert Depth: **10.70** (ft.) Flow Characteristics: **Slow**

Deposits: ☒ None ☐ Mud ☐ Sludge ☐ Debris ☐ Grease

Infiltration: **None** Pipe Seal Cond: **Unknown**

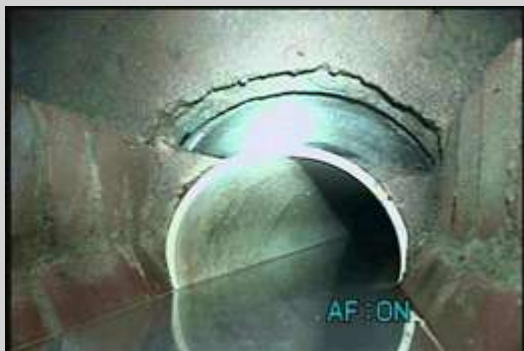
7 O'Clock Inflow

8 in. Circular Gravity Sewer
Pipe In @ 7 O'Clock

Pipe Material: **PVC** ☐ Pipe Lined

Infiltration: **None** Pipe Seal Cond: **Unknown**
